**Investigations on Interlaminar Fracture
Toughness of T300/914 Composite and Severe
Plastic Deformation of C70600 Alloy**

Thesis

NATIONAL INSTITUTE OF TECHNOLOGY KARNATAKA

July 2022

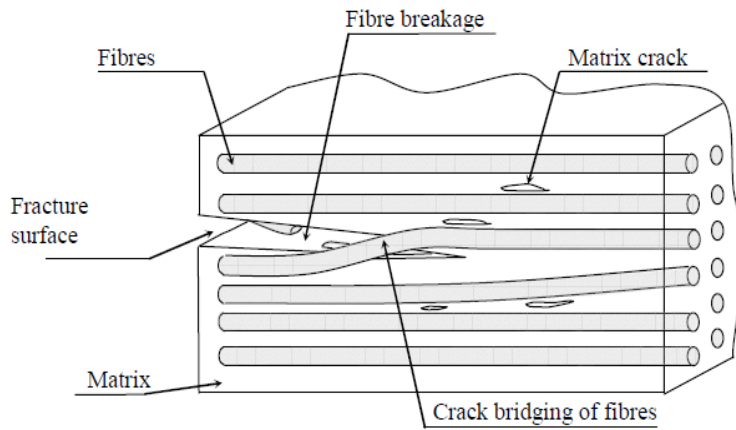
Figure 1.1 Failure modes of unidirectional composites

The following categories apply to composite laminate failure modes:

- Intra-laminar failure: internal laminar fracture (i.e., matrix crack, fibre breakage, matrix-fibre debonding)
- Inter-laminar failure: Fracture between two adjacent plies, parallel to the plane of the fibres (i.e., delamination)
- translaminar failure: fracture is positioned transverse to the laminate plate.

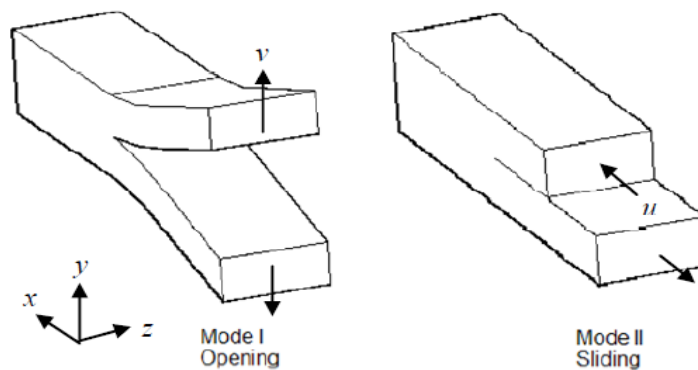
Figure 1.2 Basic fracture modes

ASTM standard D5528-01 defines two major types of fracture for laminated composite materials based on relative displacement crack surfaces (Figure 1.2)

Mode I (Crack Opening) — Mode I type of IFT (interlaminar fracture toughness) is a crack mode in which the delamination faces split away from each other and there is no relative crack face sliding. G_{IC} denotes the crucial value of interlaminar fracture toughness for delamination development in this mode.

Crack sliding mode (Mode II) — There is no relative crack face opening (in the direction perpendicular to the leading edge). Delamination faces move over each other in the direction of delamination growth. The interlaminar fracture toughness of Mode II is indicated by G_{IIC} .

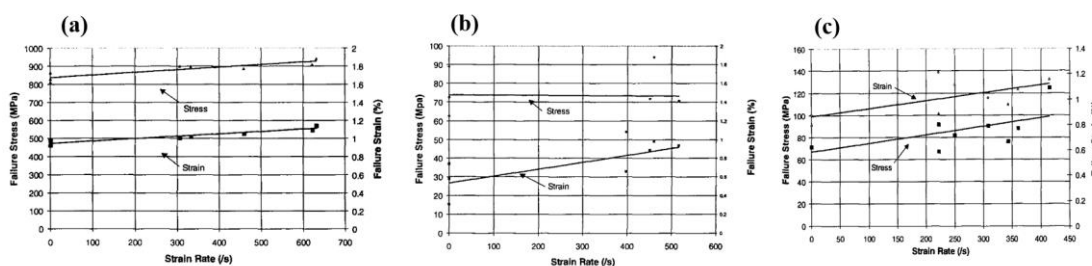
Figure 2.1 (a) In-plane tensile test (b) through thickness tensile test (c) shear test results with respect to applied strain rate. (Hou and Ruiz 2000)

S. R. Hallett and C. Ruiz (Hallett and Ruiz 1997) tried to identify the dependence of the in-plane tensile test, through-thickness tensile test and shear test on strain rate by split Hopkinson pressure bar apparatus. It was experimentally found (Figure 2.1) that all three parameters were dependent on the applied strain rate.

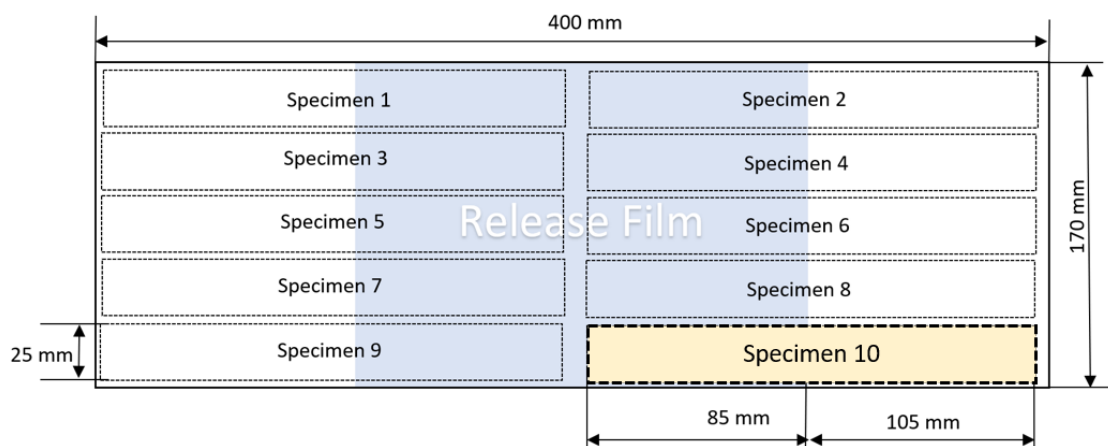
Figure 3.1 Machining layup of Mode II laminate

Laminates were made by stacking T300/914 prepreg cut to required dimensions. Laminates were placed one after the other in a single direction. To create the requisite artificial fracture, laminates were made out of 48 layers of prepreg with a release film added in the intermediate plane. All artificial cracks in the laminates were made of high-temperature no-bleed release film (Fluorinated Ethylene Propylene), that had been soaked in release agent (boron nitride complex) for 24 hours before being inserted into the layup. Both Mode I and Mode II laminates were vacuum bagged to 0.4 bar and cured for 2 hours at 170°C. A steady pressure of 0.4 bar was established in the autoclave machine. Laminates were 370mm x 170mm in size for Mode I and 400mm x 170mm in size for Mode II. Using a diamond-coated band saw cutter, laminates were reduced to 10 specimens measuring 165mm x 25mm for the Mode I test (Figure 3.2). Figure 3.1 shows a laminate sample cut to 190mm x 25mm dimensions for Mode II.

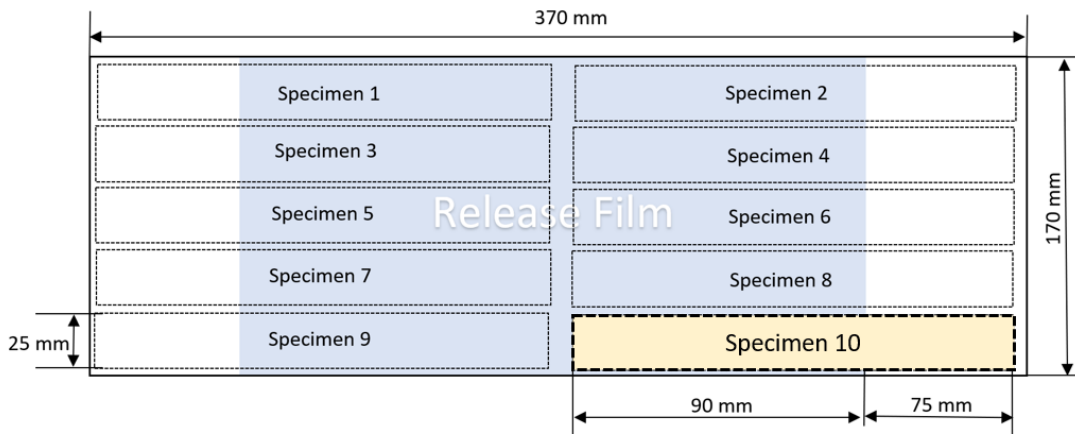
Figure 3.2 Machining layup of Mode I laminate

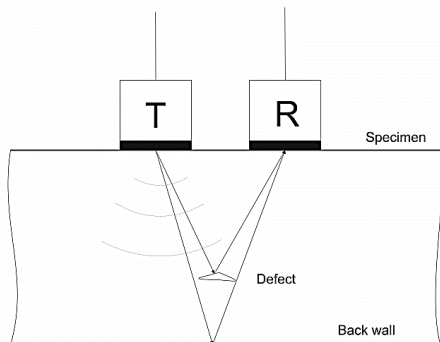
Figure 3.3 Schematic representation of working of Pulse Echo test

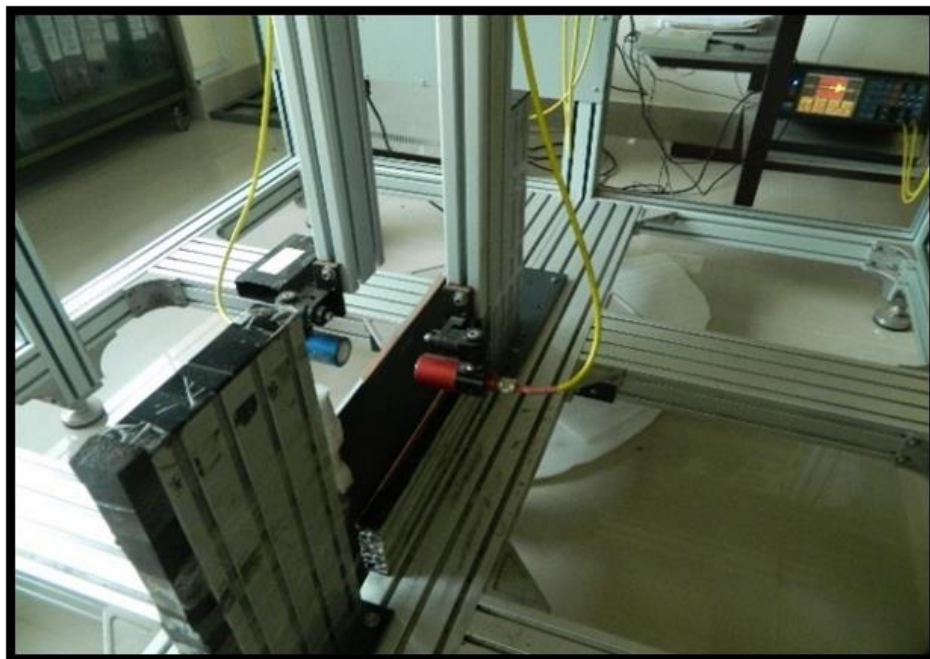
Figure 3.5 Specimen mounting in C-Scan apparatus

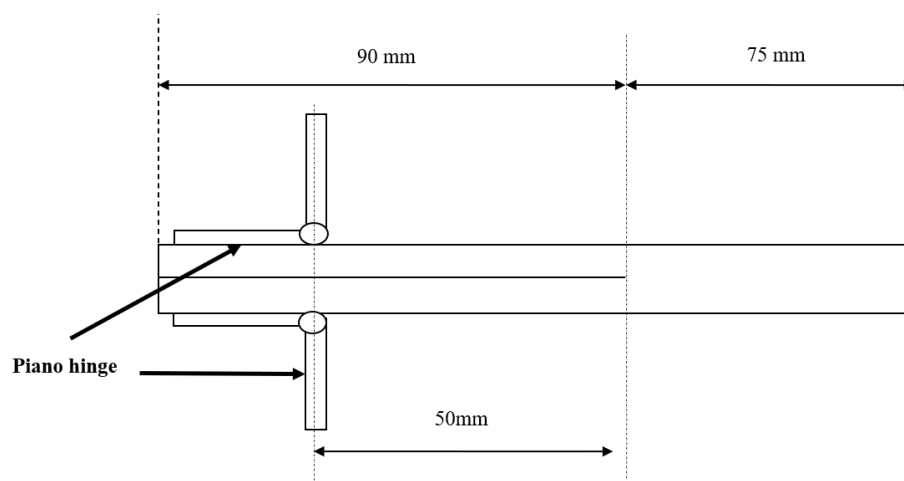
Figure 3.7 Location of Hinges

Hinges are attached at the delaminated region as shown in the Figure 3.7

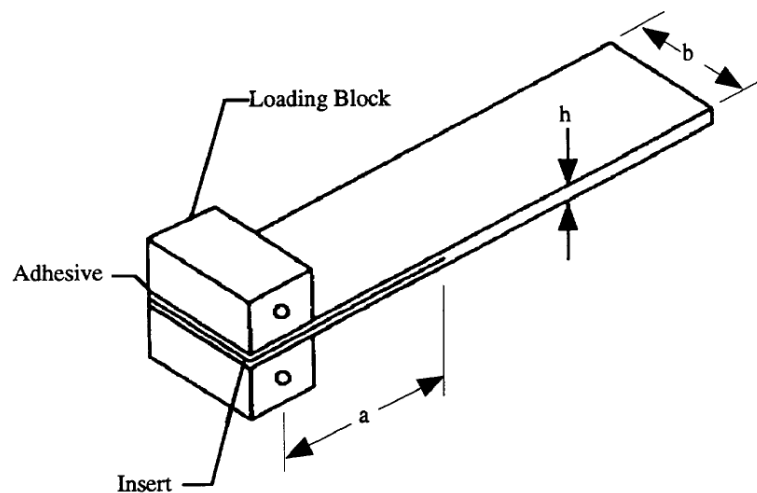
Figure 3.8 DCB specimen geometry and notation

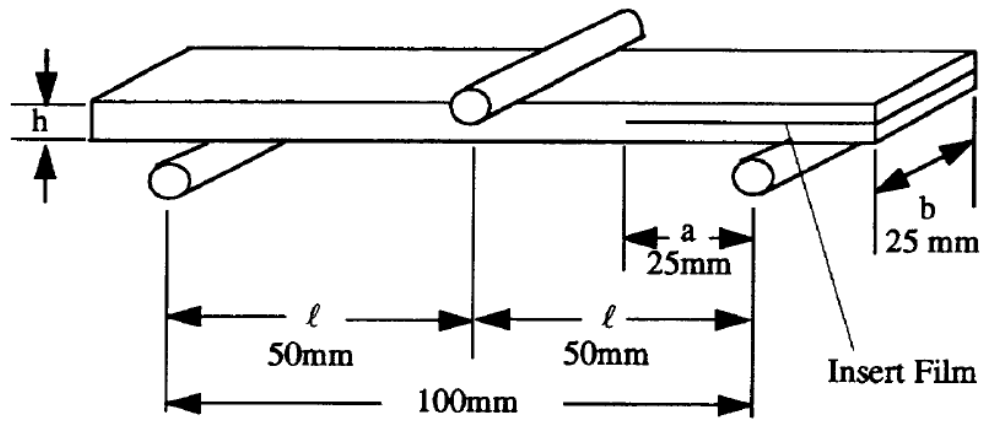
Figure 3.9 ENF Specimen, Fixture, and Dimensions

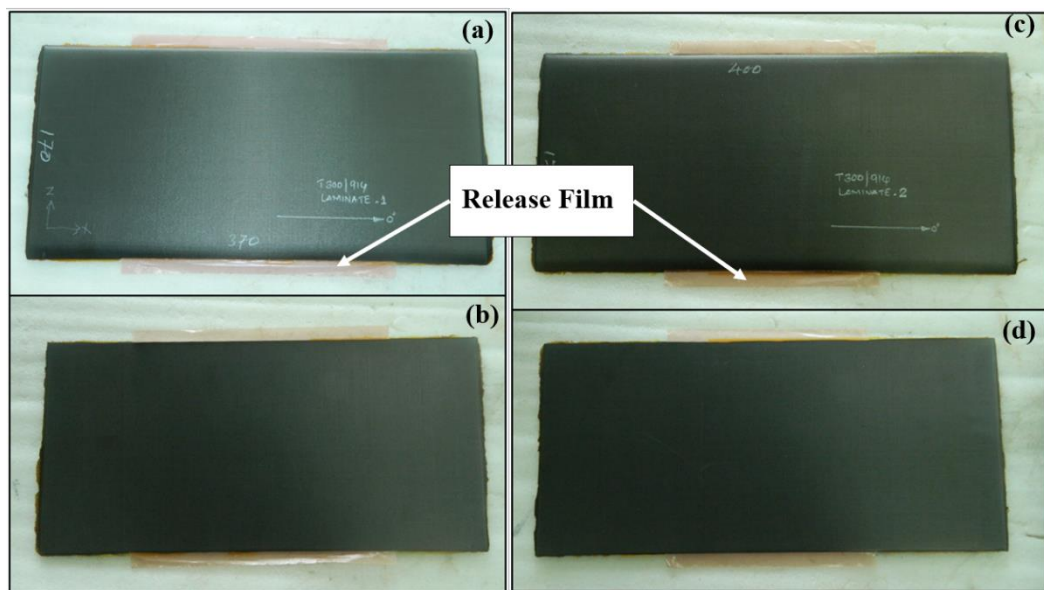
Figure 4.1 Mode I laminate (a) front face (b) back face, Mode II laminate (c) front face (d) back

Figure 4.1 shows the laminates after autoclave curing for 2 hours for Mode I and Mode II. The position of the release film is also indicated in the figure. Laminates are of Size 370 X 170 mm and 400 X 170 mm, respectively, for Mode I and Mode II. These laminates are trimmed to specimen dimensions using a diamond-coated band saw cutter.

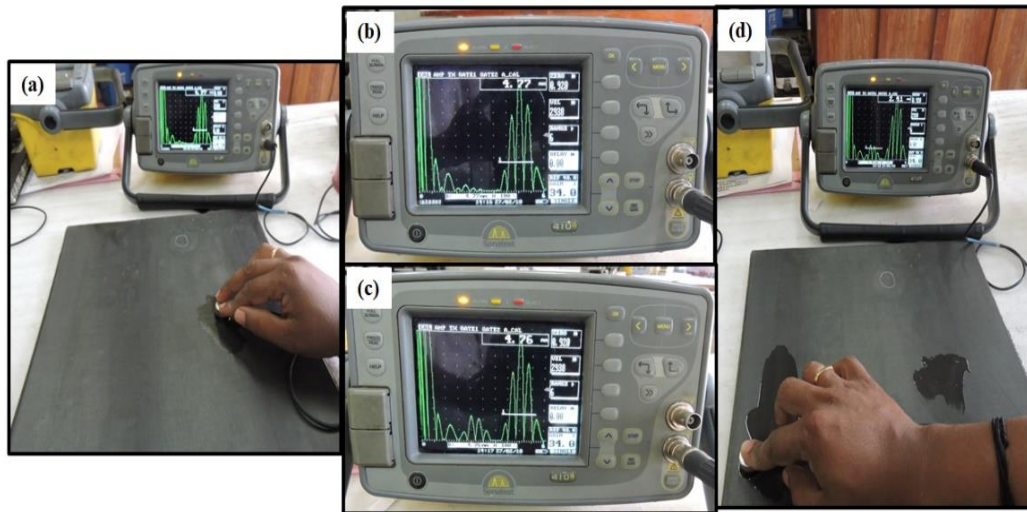
Figure 4.2 Pulse echo readings of laminate with release film not soaked in release agent (a) & (b) area without delamination, (b) & (d) delaminated region

are caused by echo reflected from the laminate's top and bottom surfaces. A third peak appears in between the previous two sets of peaks when the pulse signal is delivered across the thickness of the laminate where the release film is positioned (Figure 4.2 (c)). It is a sign that there is a substance present that has a different density than the parent material.

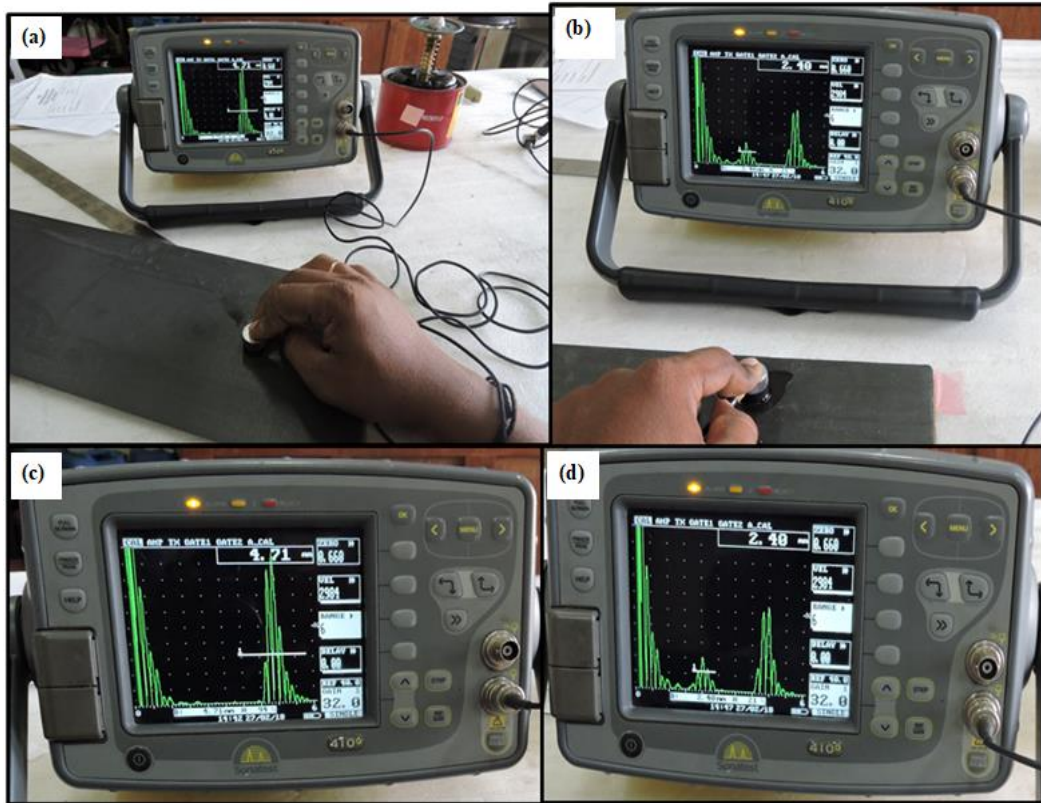
Figure 4.3 Pulse echo readings of laminate with release film soaked in release agent (a) & (b) area without delamination, (b) & (d) delaminated region

The strength of signal reflected off the bottom surface of the laminate would decrease if it were delaminated, as seen in (comparing Figure 4.3 (c) and (d)). Pulses that would be transmitted to the opposite side of delamination would be decreased due to the existence of delamination (the rest would be reflected or absorbed by delamination), resulting in a reduction in signal echoing from the bottom surface. The release film that produced delamination in the laminate was created by soaking it in a release agent for 24 hours before inserting it in the laminate during the manufacturing process.

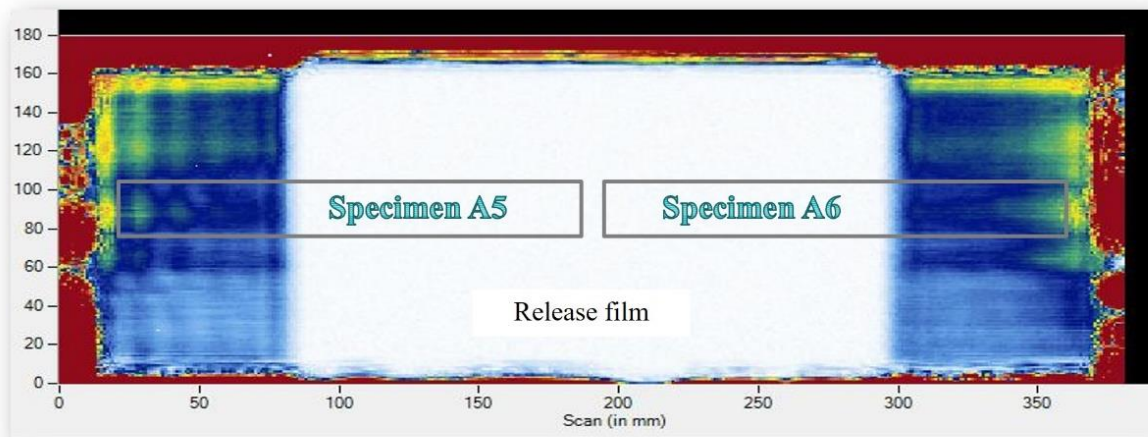
Figure 4.4 C Scan result of Mode I laminate

Mode I laminate and position of specimens B3 and B4 from Mode II laminate are shown in the Figure 4.4 and Figure 4.5 respectively.

Where, P and δ are the load and total crack opening displacement, respectively, b is the specimen width, a is the length of delamination from loading points to crack tip. Interlaminar fracture toughness of Specimen A2 at different crack lengths are calculated and shown in Figure 4.6. Modified Beam Theory (MBT) procedure is widely accepted for calculating Mode I interlaminar fracture toughness of a specimen. Figure 4.6 shows Mode I interlaminar Fracture Toughness values of all specimens tested. It is noted that specimens A5 and A6 show higher interlaminar fracture toughness due to a higher degree of compaction than in other regions (Figure 4.4).

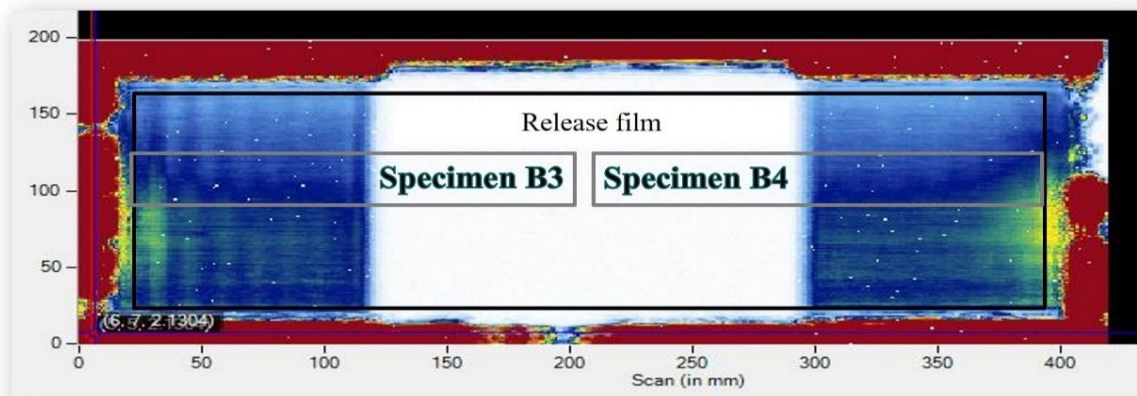
Figure 4.5 C Scan result of Mode II laminate before machining

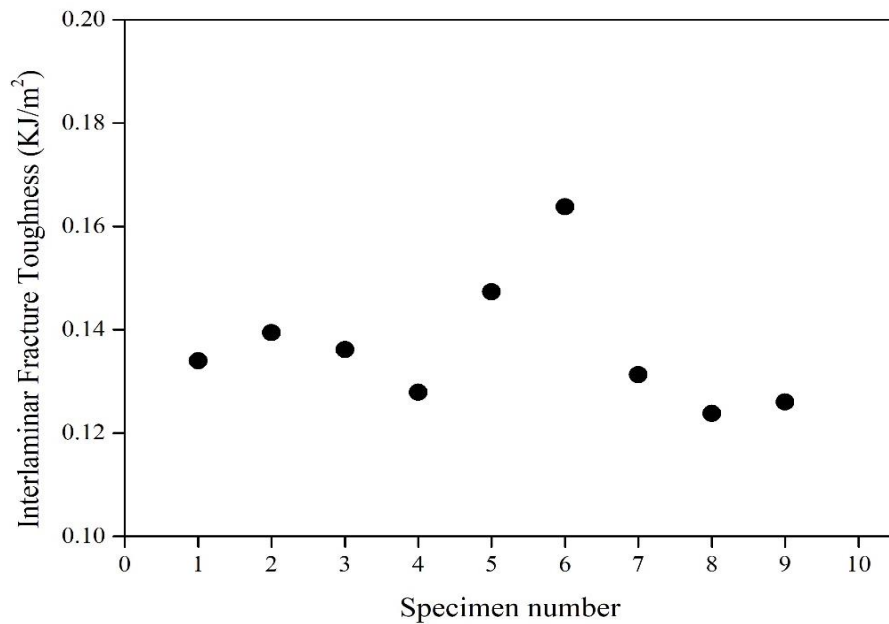
Figure 4.6 Mode I Interlaminar fracture toughness

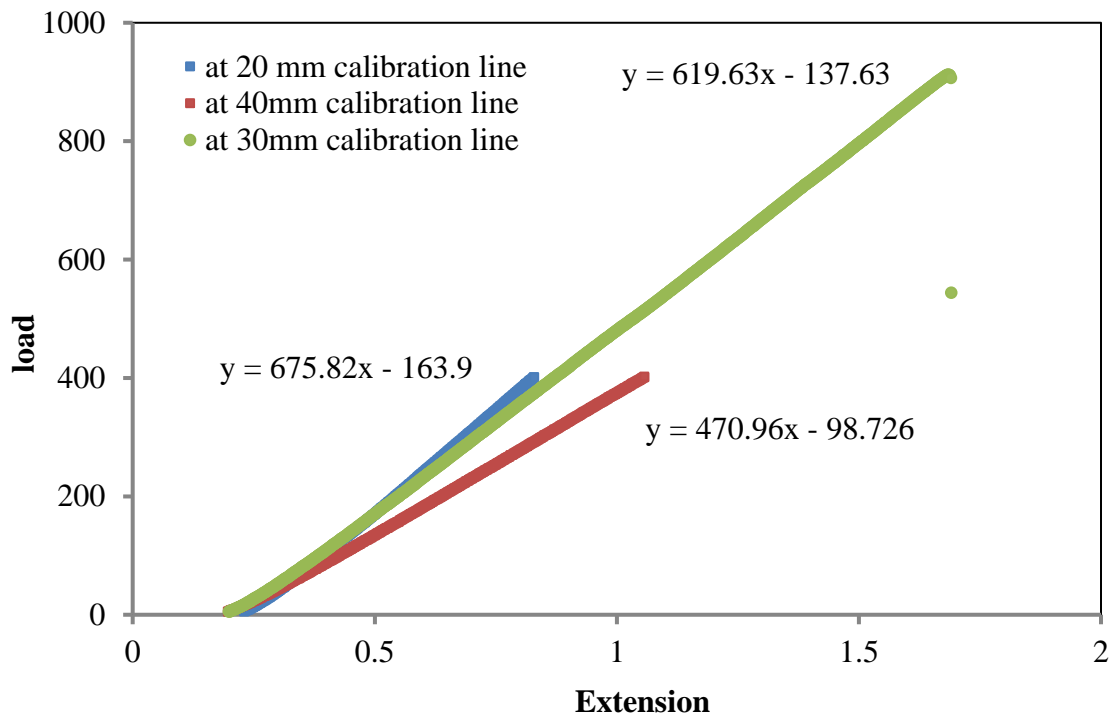
Figure 4.7 load vs displacement for specimen 1

Length of specimen L(mm)		=190
Width of specimen B(mm)		= 25
Thickness of specimen 2h(mm)		=4.8
Crack length (a_1) (mm)		=20
Crack length (a_2) (mm)		=30
Crack length (a_3) (mm)		=40
Compliance load applied at 40mm compliance line (N)		= 400
Slope of load vs Displacement curve (Figure 4.7)	m_1	=470.9
Compliance load applied at 20mm compliance line (N)		= 400
Slope of load vs Displacement curve (Figure 4.7)	m_2	=675.8
Maximum load at failure P_{max} (N)		=912.5
Slope of load vs Displacement curve (Figure 4.7)	m_0	=619.6

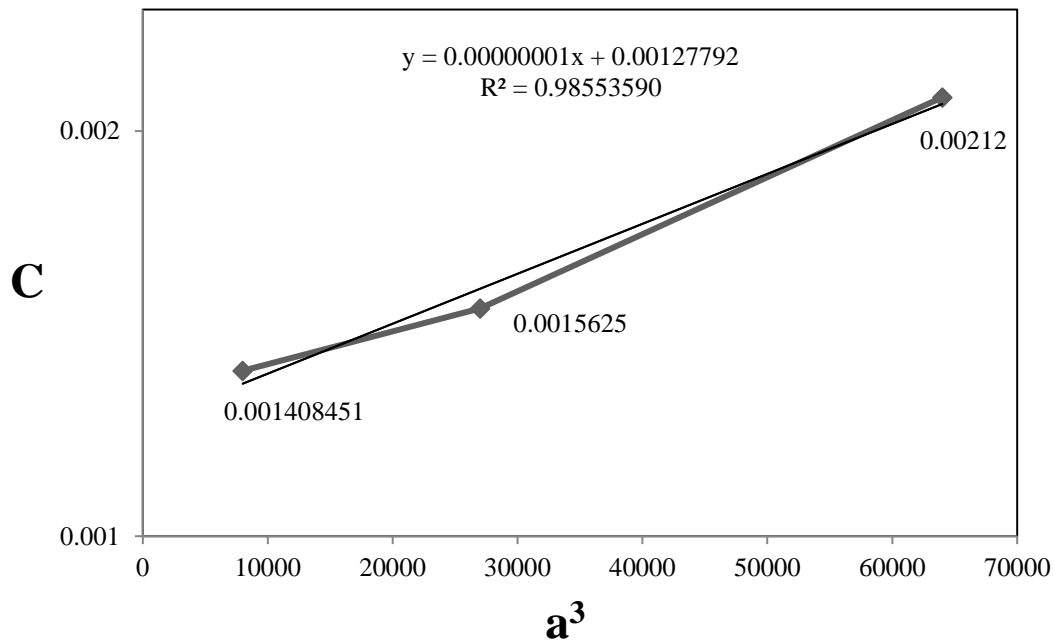
Figure 4.8 Graph of Compliance vs cube of respective crack length

Slope m = 0.00000001

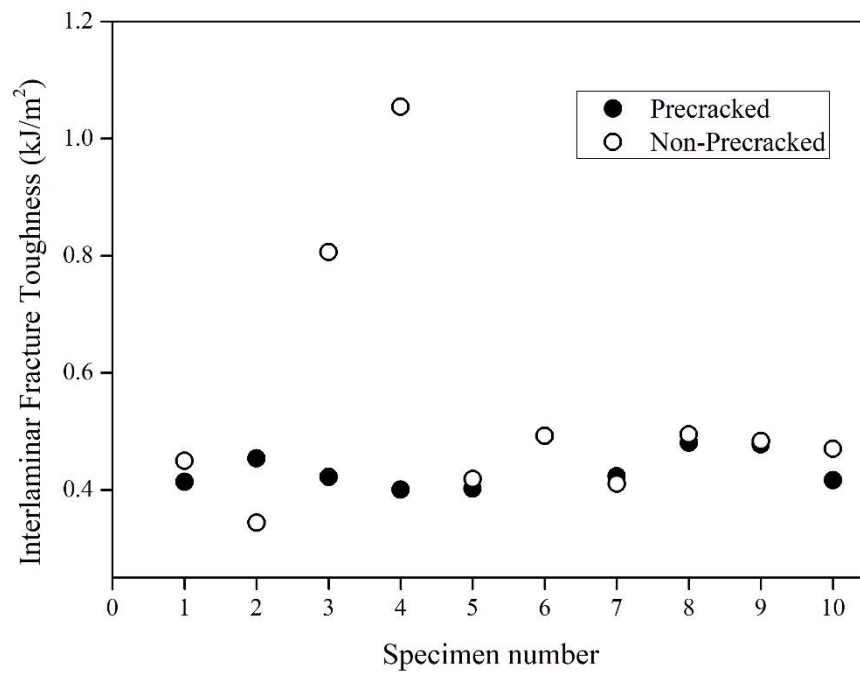
Figure 4.9 Mode II Interlaminar fracture toughness

Mode II interlaminar fracture toughness for Non-pre-cracked specimen of all the specimens are calculated and the results are shown in Figure 4.9

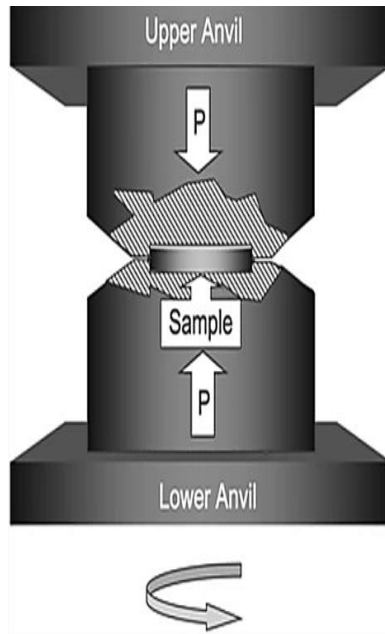
Figure 7.3 Schematic representation of High-Pressure Torsion setup (Xu et al. 2008)

High-pressure torsion is a process where the material, in the form of a disc, is subjected to compression load, as well as, torsion load at the same time. Material is held between a fixed support and a rotatable lower anvil. Upper anvil and lower anvil together constrains all movement of material. Upper anvil moves towards lower anvil and applies a compressive load on material which is in the range of Giga Pascals. Lower anvil is rotated by a predefined angle to produce torsional load on the material (Figure 7.3). Because of the frictional force between the intersecting surface of upper anvil, material and lower anvil, both loads together create shear strain in material, causing grain refinement, which is found to vary from centre of the disc to the outer edge.

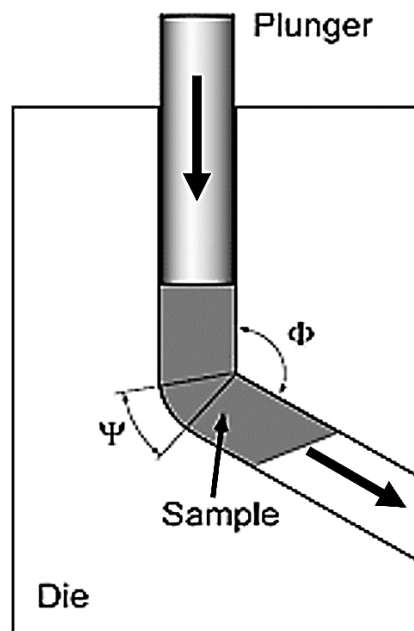
Figure 7.5 Schematic representation of ECAP process

ECAP is an extrusion process introduced during 1970s and 1980s (Zhou et al. 2021). It gained popularity among researchers during 90s and is still in active use. Basic intention of this process is to introduce strain in the material and causing work hardening of the material which improve the property of the material. Advantage of this process over other formation processes like forming, extrusion, rolling and drawing processes is that the initial material and the processed material have the same cross-sectional area and strain is introduced without any change in dimensions of material. Also during extrusion, small defects like voids, porosity and blow holes are rectified. Figure 7.5 depicts the schematic representation of the ECAP process.

In ECAP, sample is passed through a channel which is bent at an angle ϕ . As the sample passes through the bend, shear strain is introduced (Figure 7.5), which causes grain refinement. As there is no change in cross section of the sample, same sample can be passed multiple times through the die with minimum specimen preparation between passes. With multiple pass ECAP, ultrafine grains can be formed in the sample.

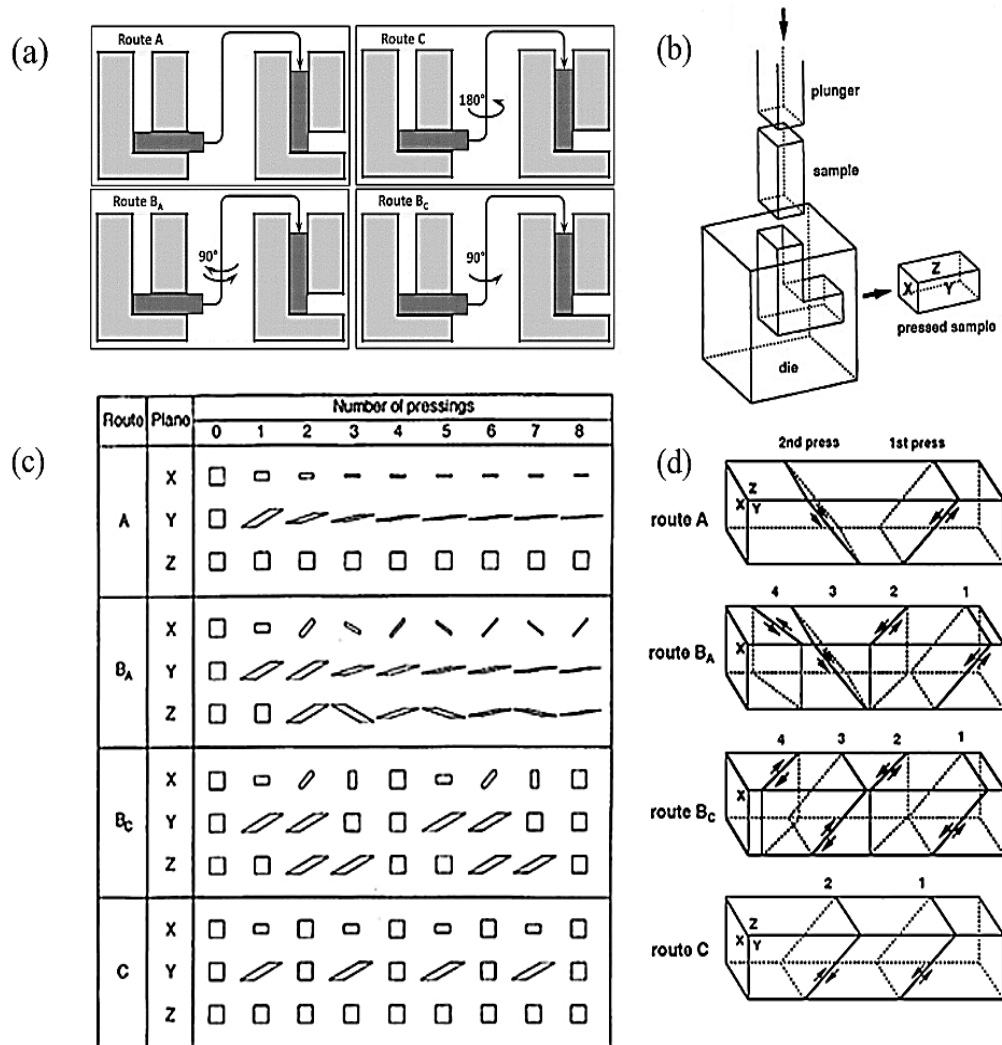
Figure 7.7 Shear plane formed during ECAP along different routes (Valiev and Langdon 2006)

processed in route A. If the specimen is rotated by 90° in the same direction, between successive passes, then sample is said to be processed in route B_C . If specimen is rotated by 90° in alternative direction during the successive passes, specimen is said to be processed by route B_A . If the sample is rotated by 180° between successive passes, processing route is called route C. Different shear planes formed during ECAP along each of the routes are schematically represented in Figure 7.7(c).

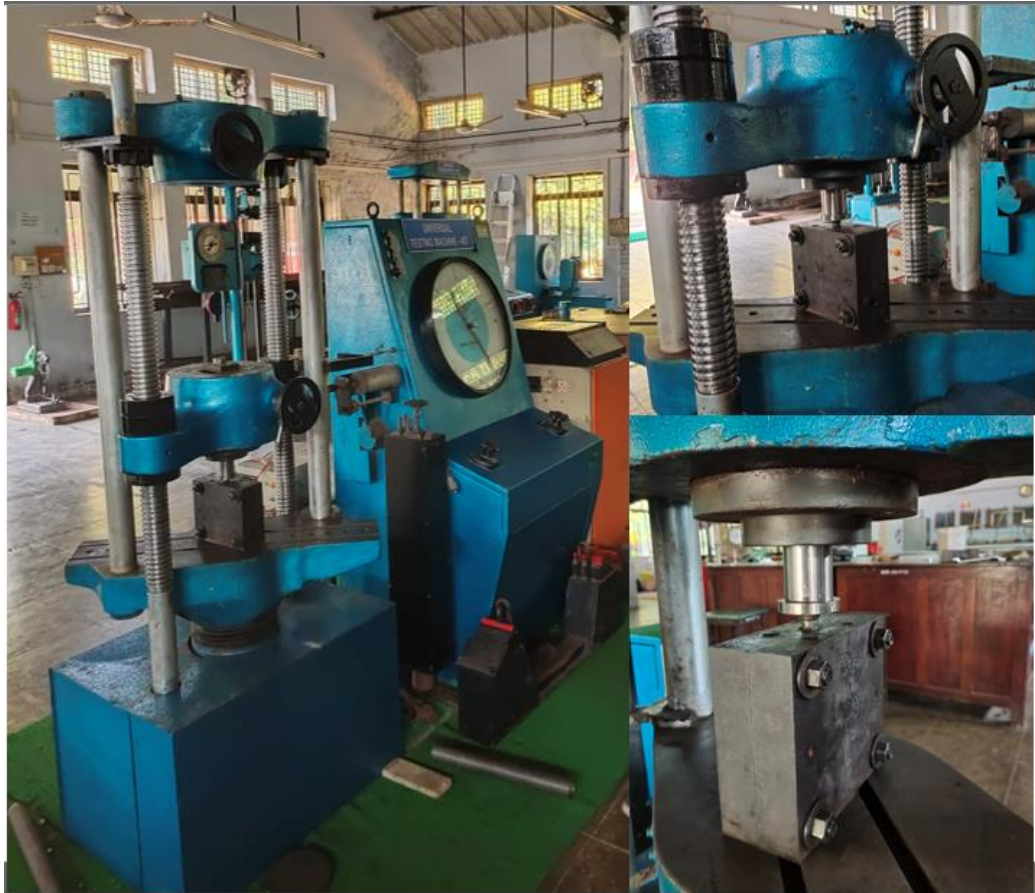
Figure 8.3 20T Universal Testing Machine

Pressing was carried out on a 40T Universal Testing Machine setup (Figure 8.3).

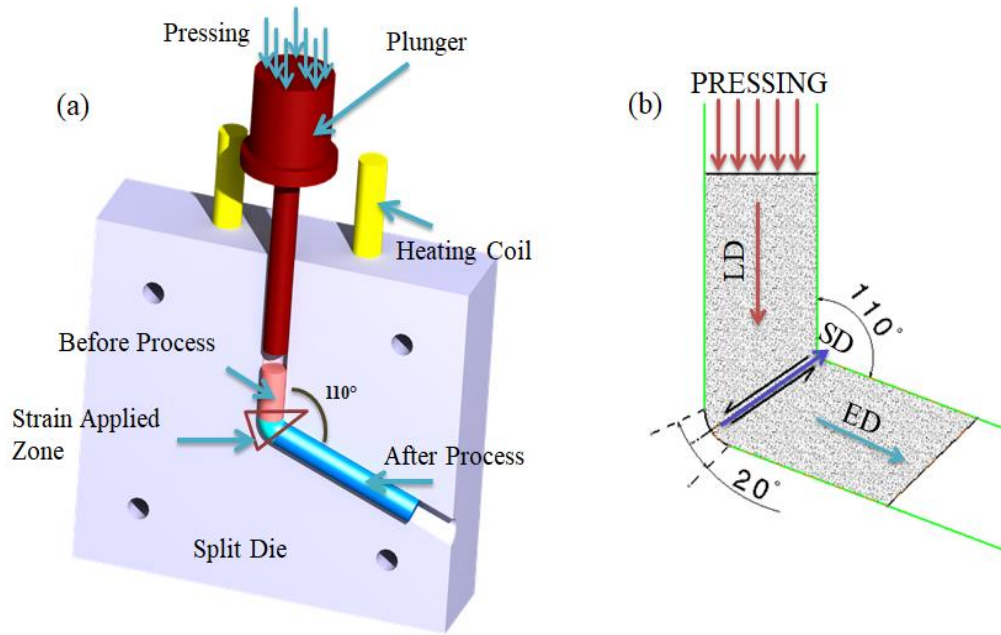
Figure 8.4 (a) Sectional view ECAP split die and plunger, (b) Material flow mechanism during ECAP [1]

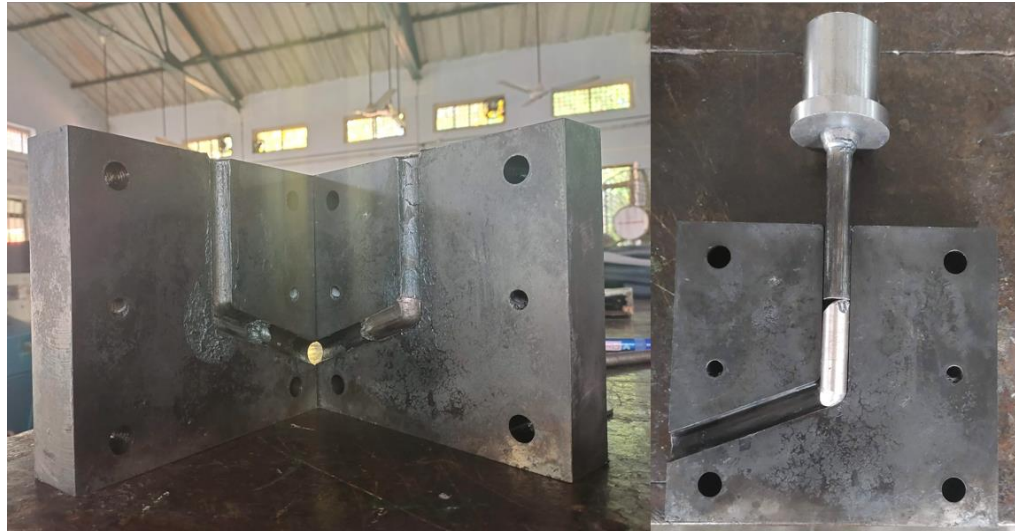
Figure 8.5 ECAP Split die

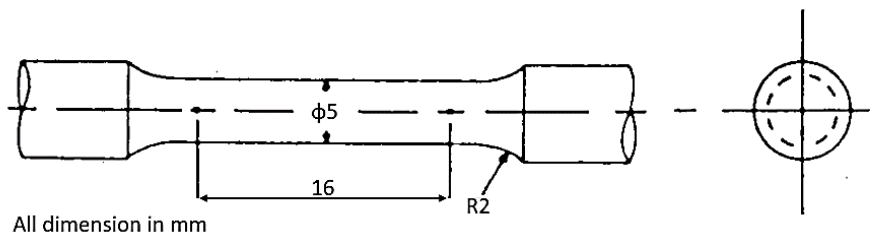
Figure 8.13 Dimensions of tensile test specimen

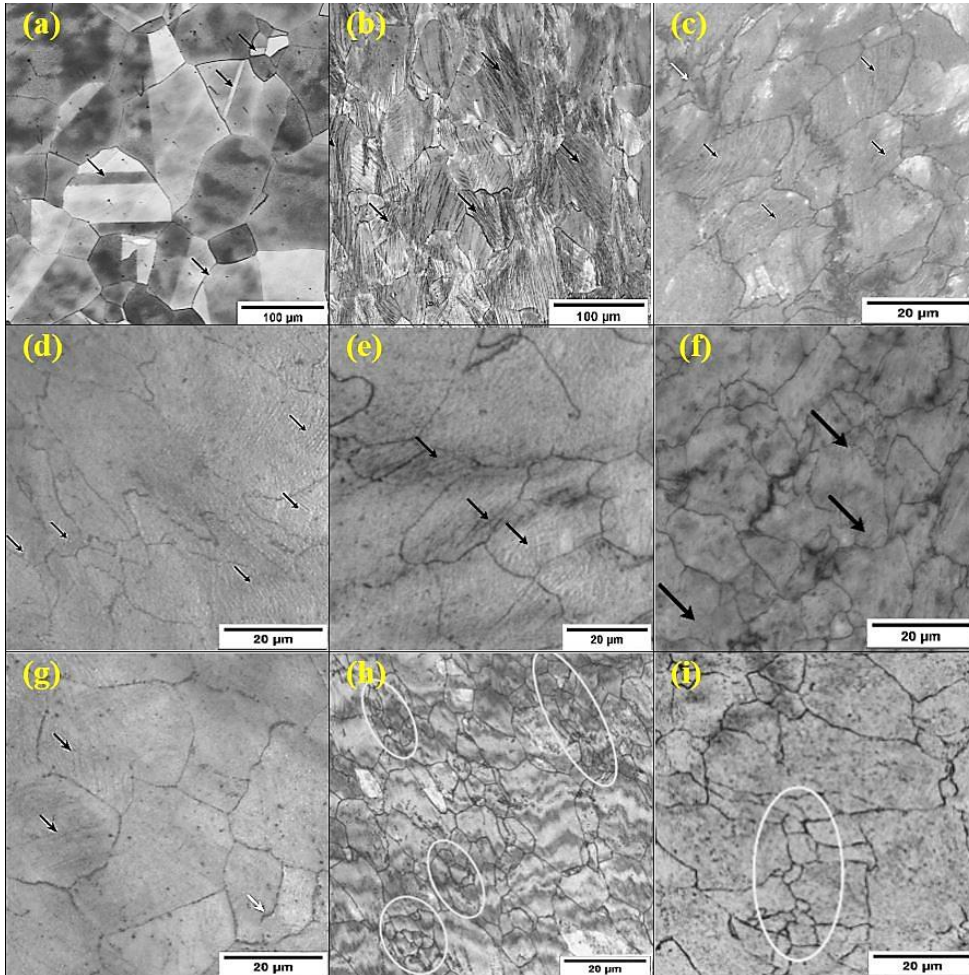
Figure 9.1 Optical microstructure of C70600 copper alloy samples in (a) homogenised condition and ECAP (b) 1P, (c) 2P, (d) 3P, (e) 4P, (f) 5P, (g) 6P, (h) 7P, (i) 8P conditions.

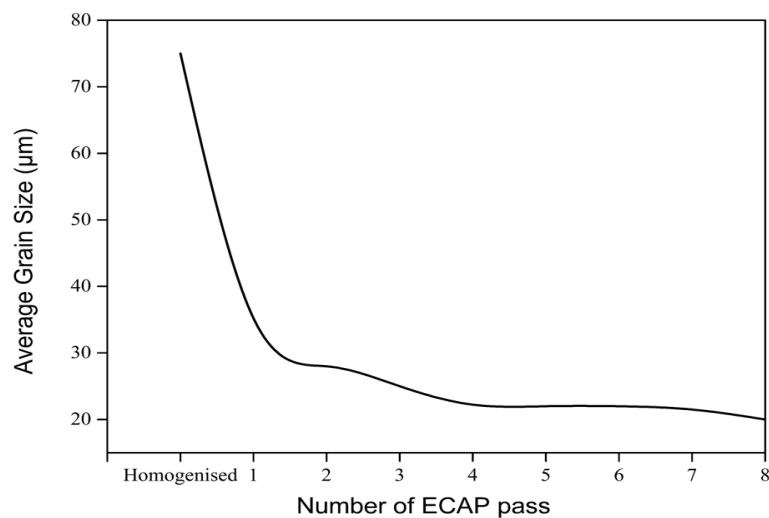
Figure 9.2 Change in average grain size with respect to number of ECAP passes

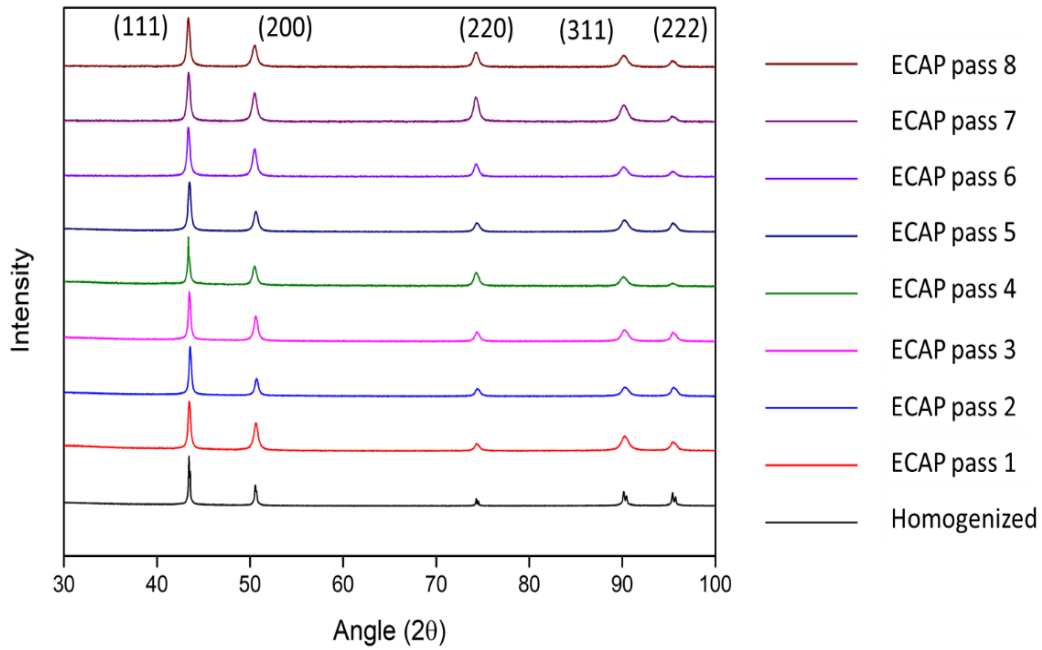
Figure 9.3 XRD graph of homogenized and ECAP processed samples

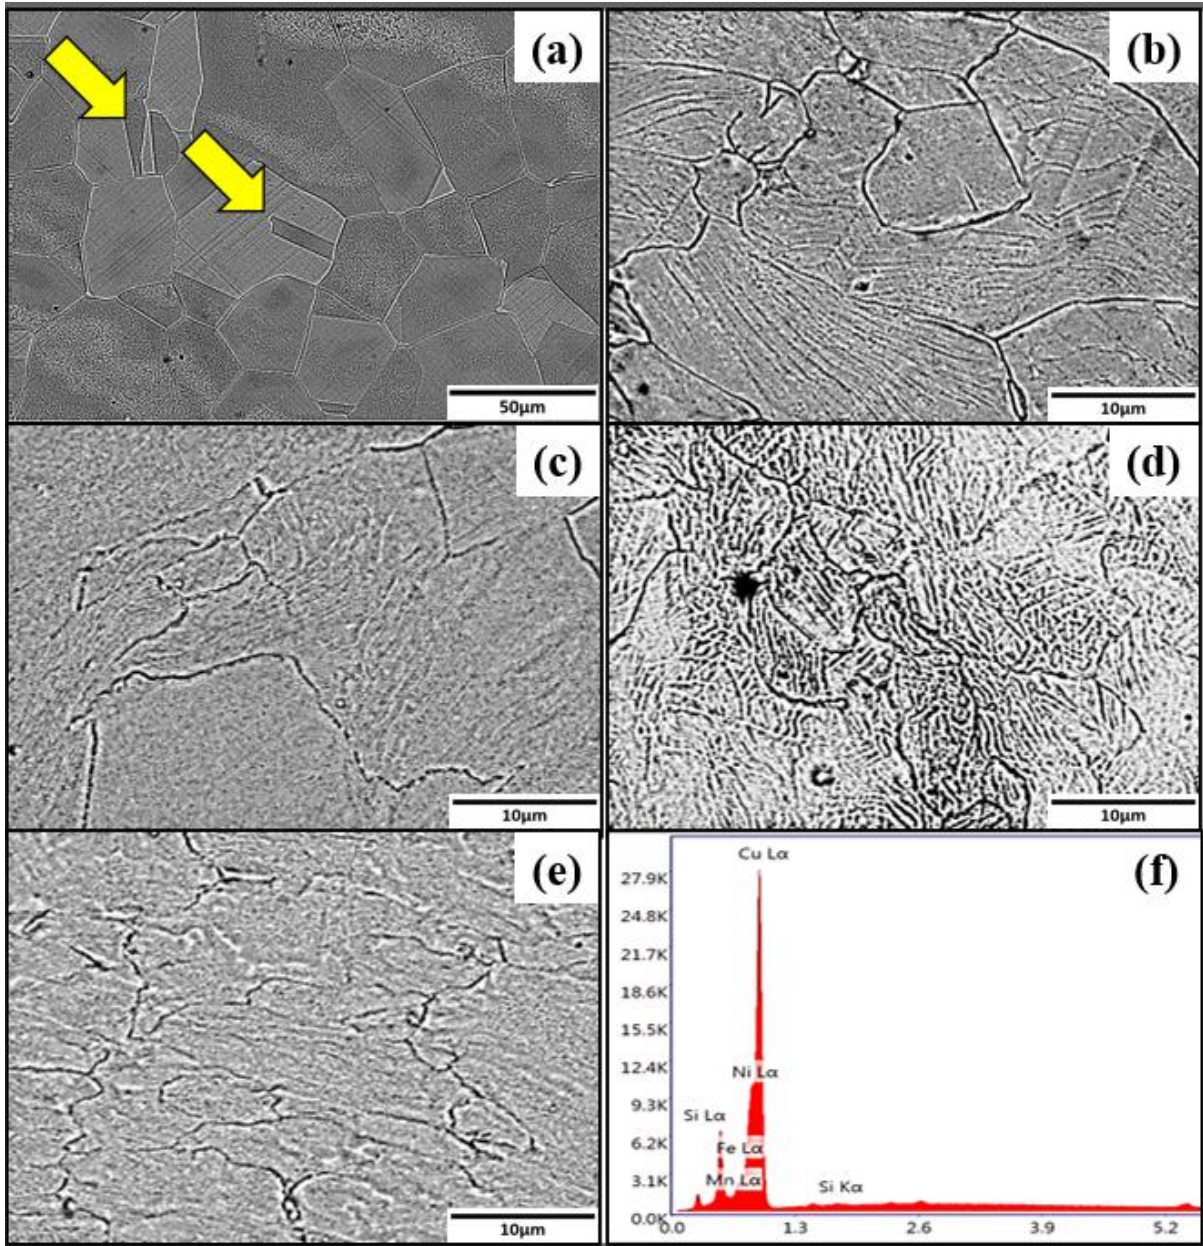
Figure 9.4 SEM image of (a) homogenized and ECAP processed samples (b) 1 pass, (c) 2 pass, (d) 3 pass, (e) 4 pass, (f) EDS data of processed sample

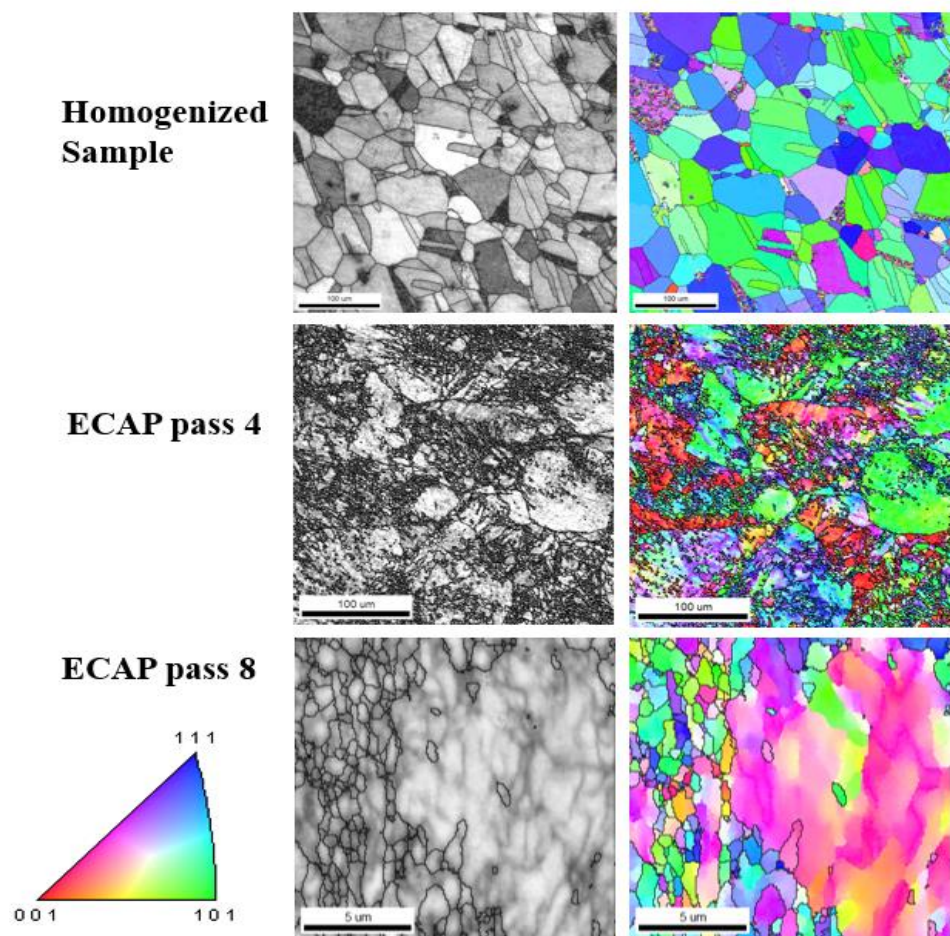
Figure 9.5 Orientation-imaging microscopy of C70600 alloy for homogenized and ECAP processed samples

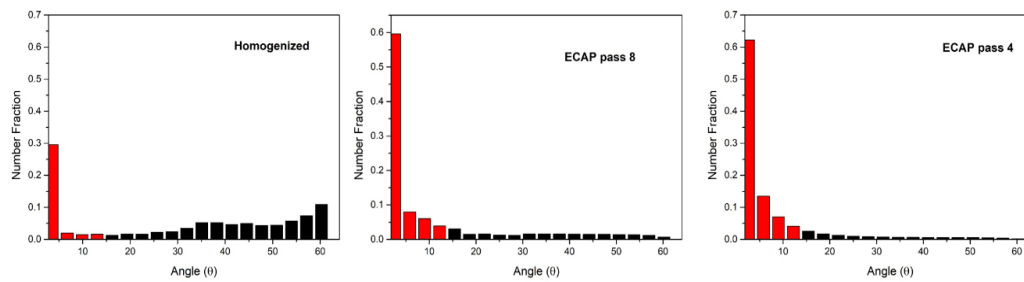
Figure 9.6 Misorientation angle distribution of C70600 alloy for homogenized and ECAP processed samples

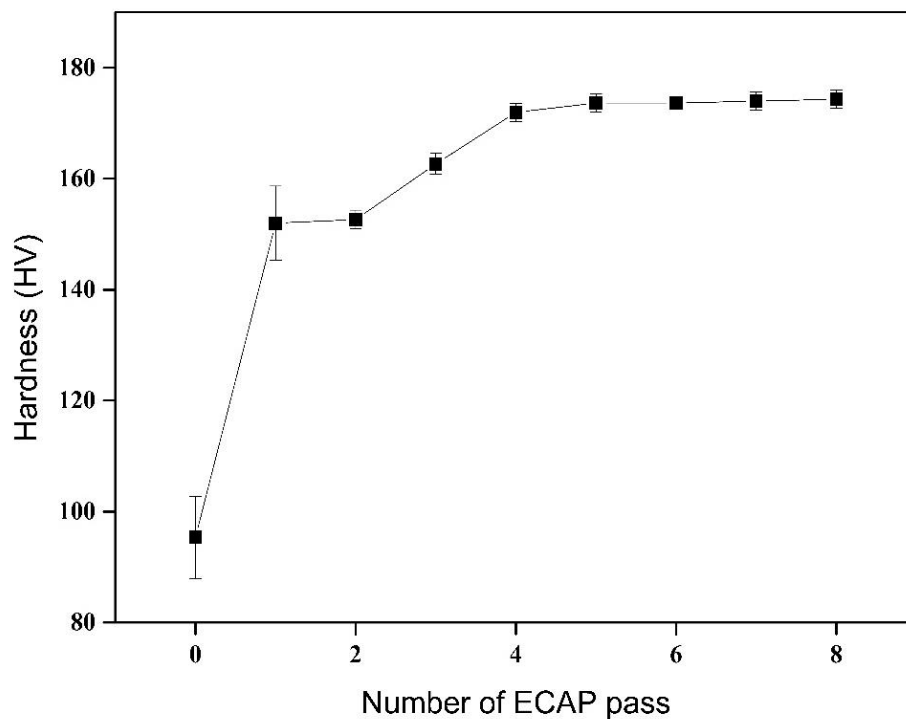
Figure 9.7 Hardness of homogenised and ECAP processed samples

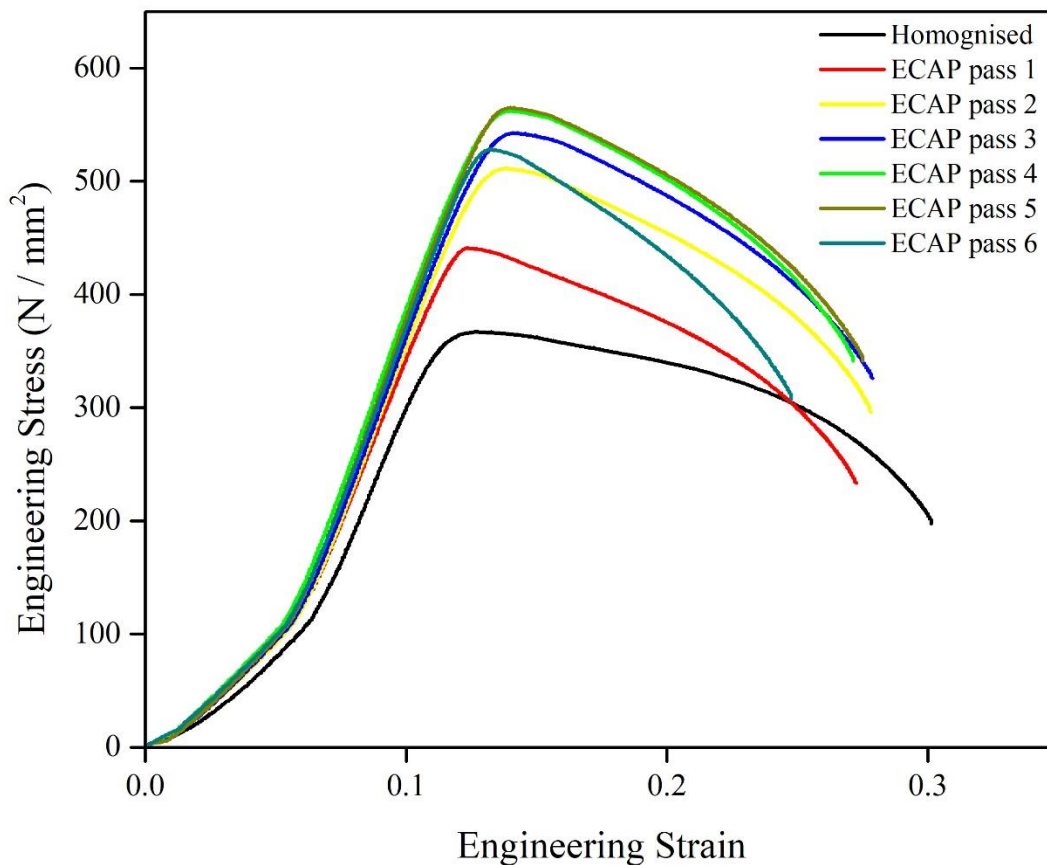
Figure 9.8 Stress vs strain graph of homogenized and ECAP processed samples
