**Investigations on Interlaminar Fracture
Toughness of T300/914 Composite and Severe
Plastic Deformation of C70600 Alloy**

Thesis

NATIONAL INSTITUTE OF TECHNOLOGY KARNATAKA

July 2022

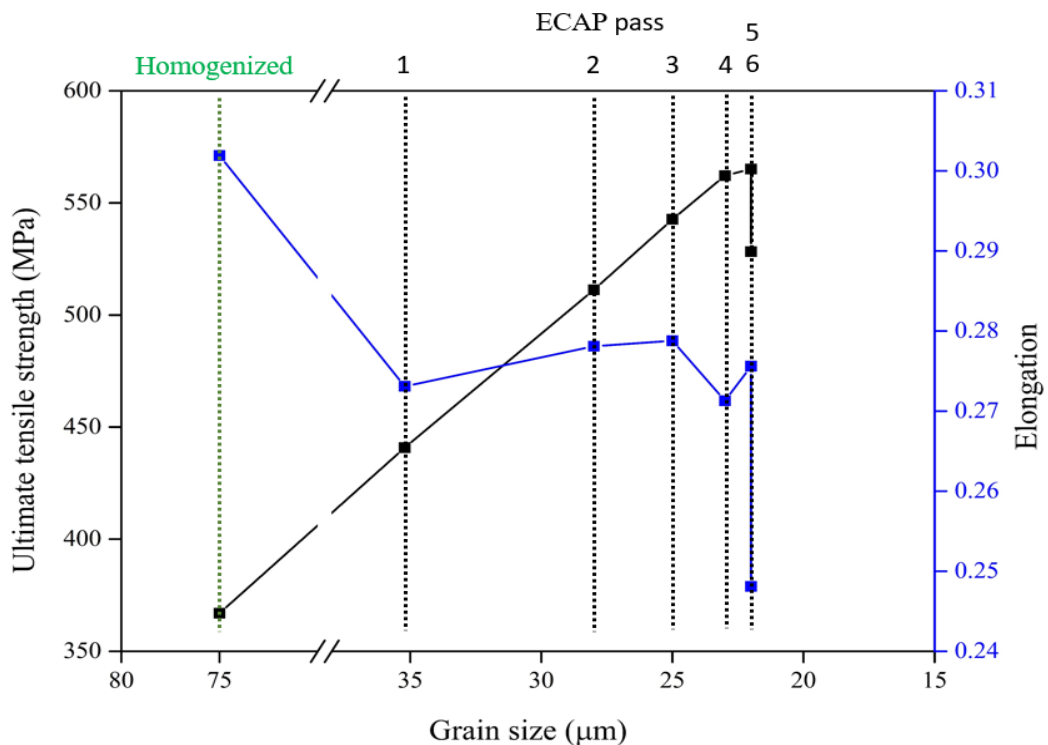
Figure 9.9 Ultimate Tensile Strength and elongation for Homogenized and ECAP processed

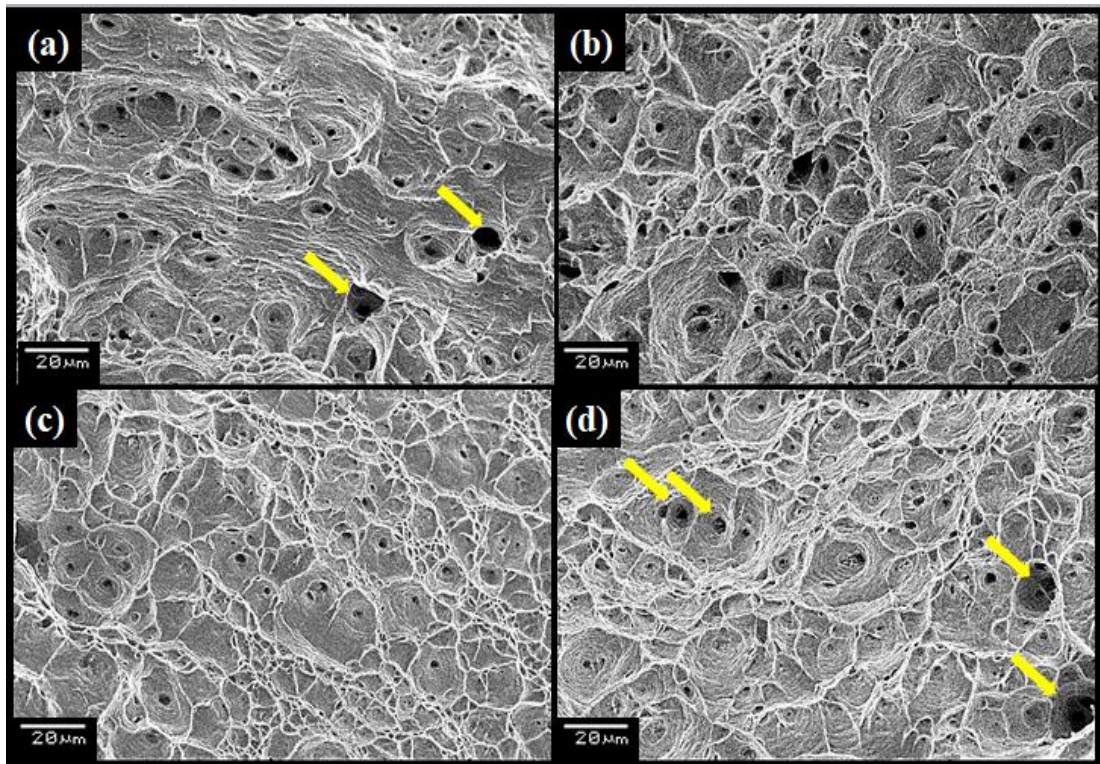
Figure 9.10 SEM image of tensile test fractured surface for (a) homogenized, ECAP pass

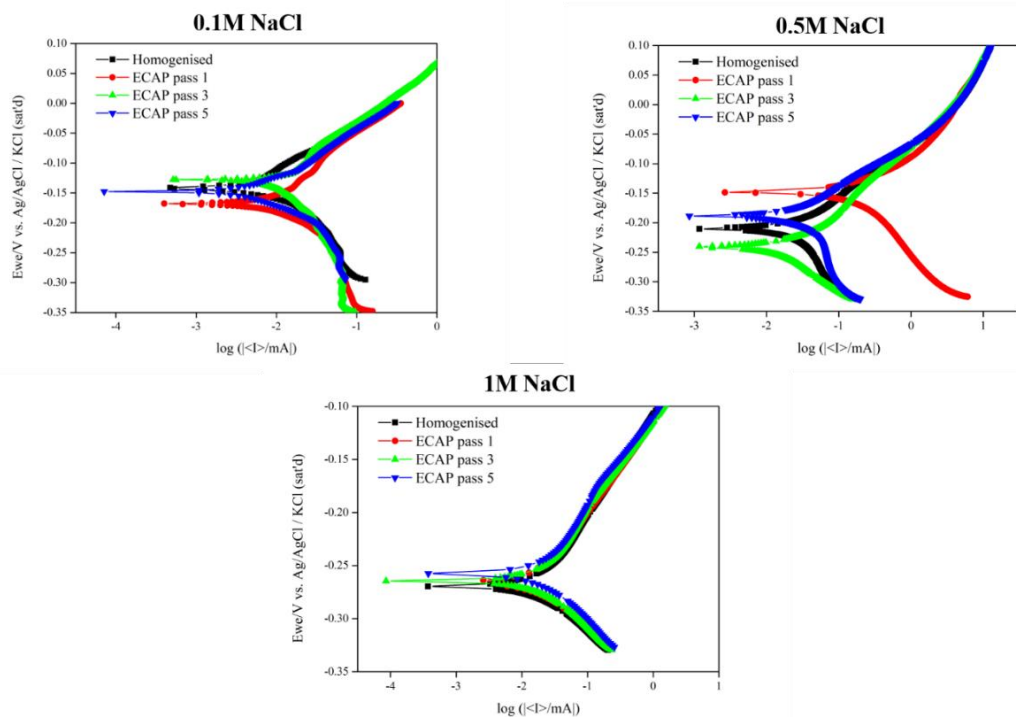
Figure 9.11 Tafel plot of Homogenized and ECAP processed samples in 0.1M, 0.5M and 1M NaCl solution

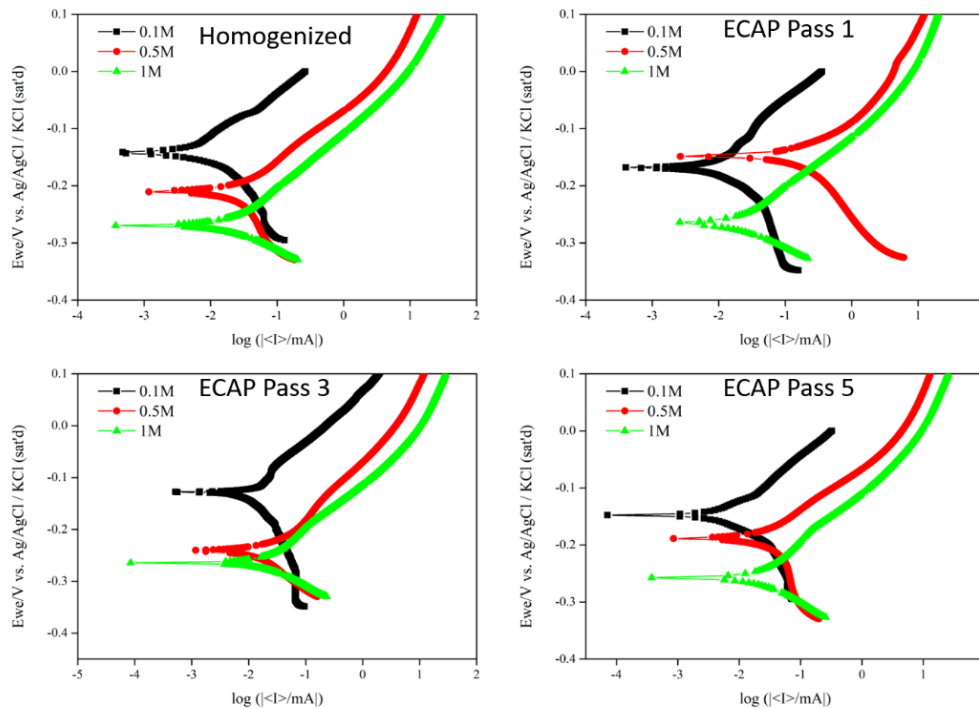
Figure 9.12 Tafel plot of homogenized and ECAP processed sample with increase in

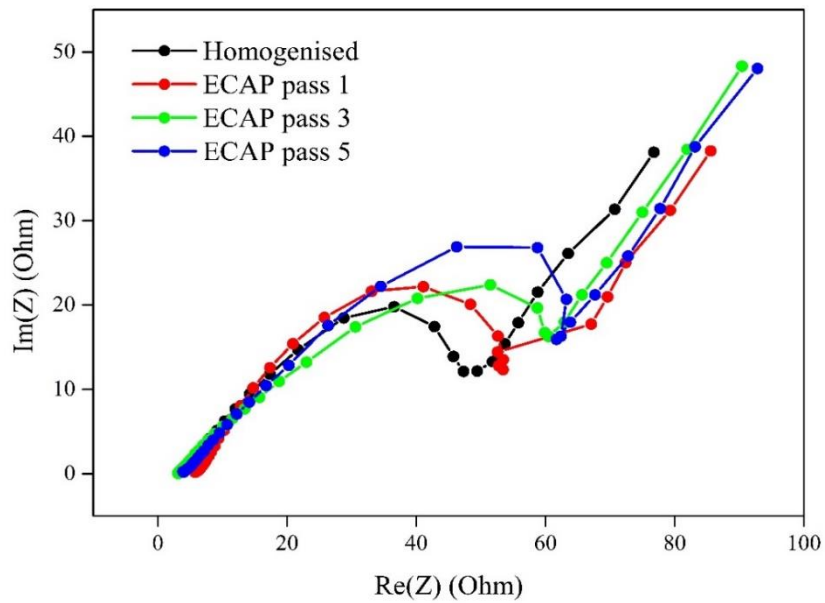
Figure 9.13 Nyquist plots for homogenised and ECAP processed Cu-Ni samples
